Mobile Pentium® II Processor Specification Update

Release Date: December 1998

Order Number: 243887-005

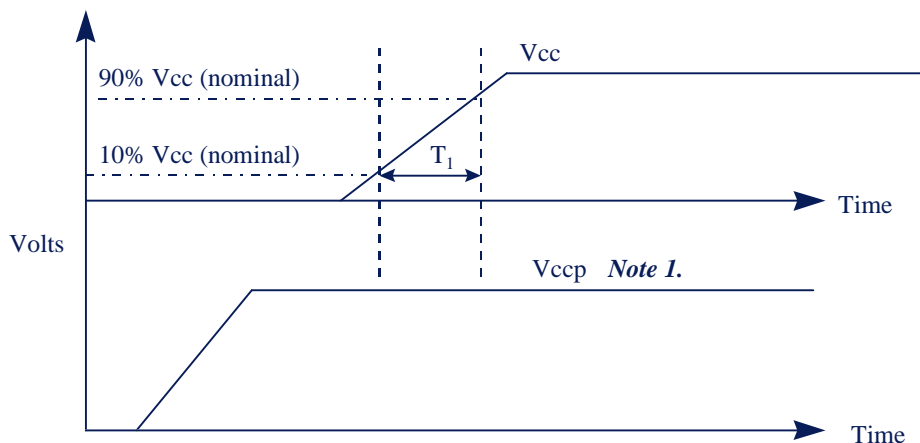
Figure 1. V_{CC}/V_{CCP} Timing Requirements (Mobile)

PROBLEM: The processor uses the PWRGOOD signal to ensure that no voltage sequencing issues arise; no pin assertions should cause the processor to change its behavior until this signal is asserted, when all power supplies and clocks to the processor are valid and stable. However, if V_{CC} ramps up before V_{CCP} , it will cause the processor to enter an invalid state.

IMPLICATION: If this erratum occurs, the system may boot normally however, the L2 cache may not be initialized.

Symbol	Parameter	Min	Max	Notes
T_1	V_{CC} Ramp Time	200 uSec		Measured between 10% V_{CC} (nom) to 90% V_{CC} (nom)
Note 1: V_{CCP} must be greater than V_{CC} during the interval in which V_{CC} rises from 20% V_{CC} to 80% V_{CC} .

WORKAROUND: For Mobile Pentium II processors, ensure that V_{CC} ramps after or with the L2 cache IO voltage (V_{CCP}). If V_{CCP} ramps after the V_{CC} , a delay circuit can be placed on the core V_{CC} to ensure that V_{CC} ramps at the same time or after V_{CCP} as shown below in Figure 1.

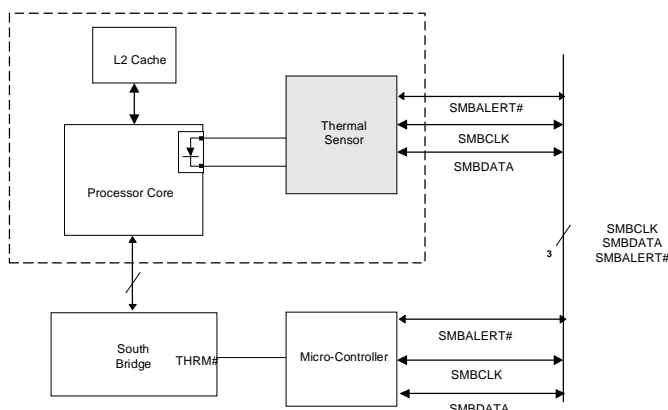
Figure 1. An Example of Microcontroller Driven Thermal Management

PROBLEM: The Mobile Pentium II processor and the Pentium II Processor Mobile Module have a thermal sensor that monitors the processor core's temperature. Please note that desktop systems could have a similar thermal device. The thermal sensor asserts SMBALERT# if the processor temperature exceeds the temperature limits set in the Alarm Threshold Registers (T_{HIGH}, T_{LOW}). It also sets the corresponding Status Register bits to identify the cause of the interrupt. Figure 1 gives one example of the how the SMBALERT# signal could be used in a system.

Under the conditions described below, the thermal sensor incorrectly generates the SMBALERT# interrupt. *All* of the following conditions must be met to trigger a false interrupt:

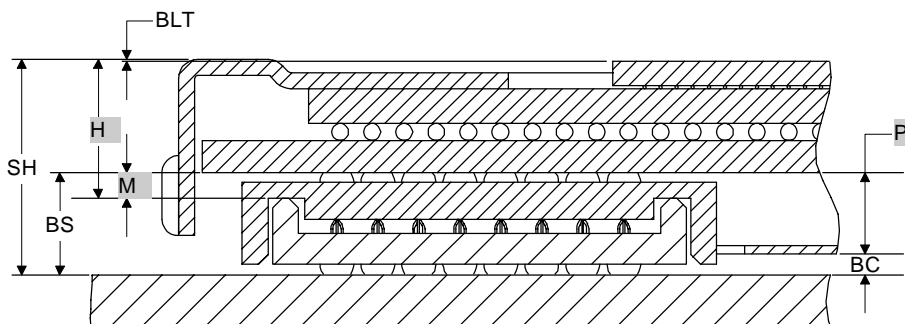
Figure 5.6. Cross Sectional View With Vertical Dimensions

B12. Misabeled Vertical Dimension Parameters

Figure 5.6 in the *Mobile Pentium® II Processor at 233 MHz, 266 MHz, and 300 MHz* datasheet should be replaced by the following figure:
